LOST IN SPACE REPAIR: IBM-5155 SERIAL CARD.

H. Holden. August. 2018.

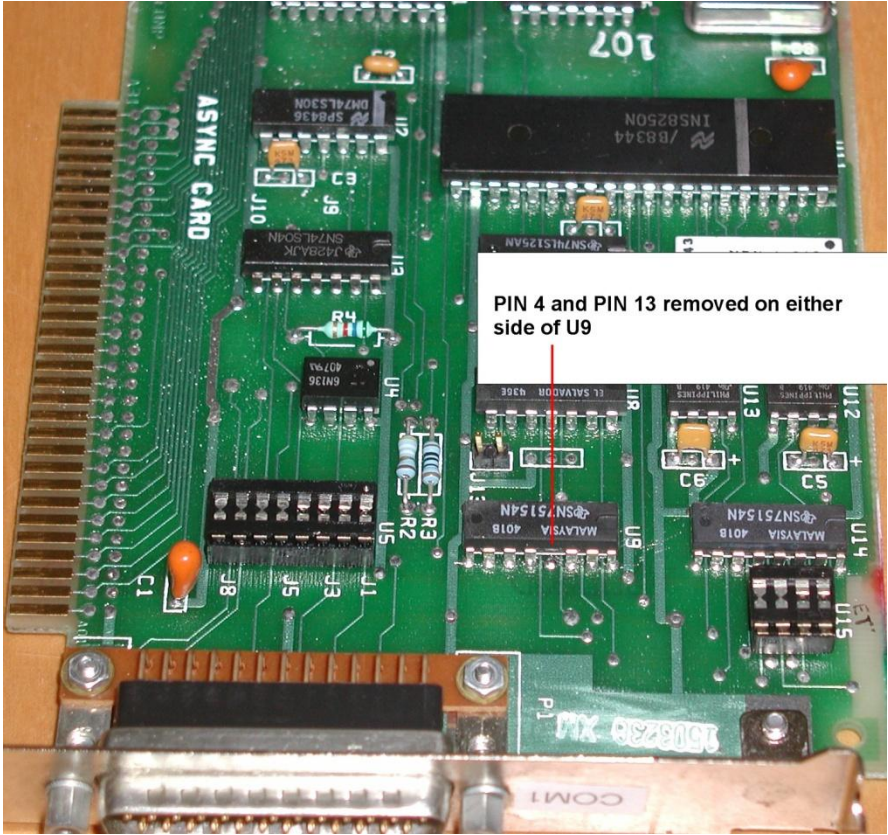
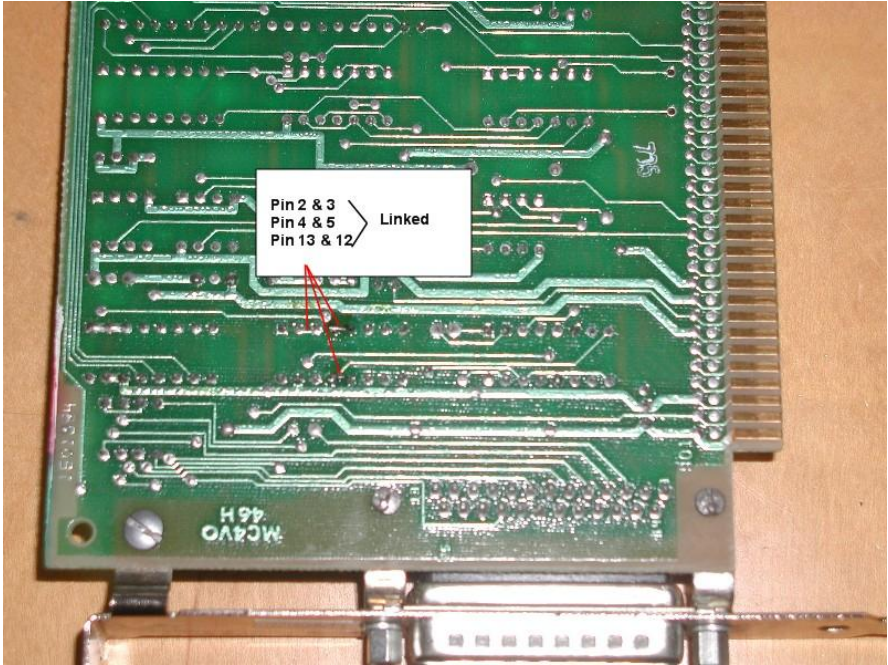
Inspecting the schematic for the IBM Async card, the Rx input is pin 3 of the DB25 connector and it passes directly into the input (also pin 3) of a DS75154N line receiver IC labelled U9. A quick test on the current into pin 3 of the IC demonstrated the IC had failed drawing excessive current on that pin. Right away I knew I didn't have one in my IC stocks and I would have to order them with about a 2 week delay.

However, the DS75154N contains 4 line receiver buffers. I noticed that the remainder of the buffers in IC U9 had not been used by IBM. So I clipped off U9's pin 3 and pin13, unsoldered and removed these two IC pins from the pcb.

The repair then only required 3 links on the back of the board connecting 3 pairs of adjacent pads:
