TECHNICAL BULLETIN INDEX
Sorted by Bulletin Number
04/03/86

TANDY COMPUTER PRODUCTS

DATE: December 8, 1983
REVISION DATE: April 18, 1988
BULLETIN NO: 2000:1
PRODUCT: 26-5140 High Resolution Graphics PCB
SUBASSEMBLY: AX-9450 Graphics PCB
SUBASSEMBLY REVISION: Rev. PP2

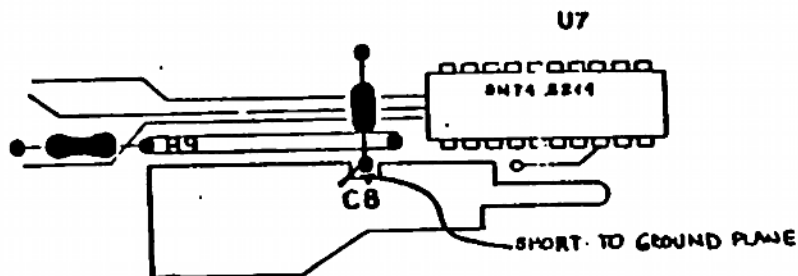
Figure 1

DISCUSSION/PROCEDURE: Some early production hard drive controller boards were missing a resistor (R28), had two wrong valued capacitors installed (C5 and C6), and had one capacitor which was not grounded properly (C8). All Tandy 2000 hard drive controller boards should be checked for the following:

1. Make sure R28 has a 470 ohm 1/4 watt 5% resistor installed in that silk screen position.
2. Check C5 and C6 to insure 100 pfd capacitors are installed and not 150 pfd capacitors.
3. Check C8 to insure that the open pin is attached to the ground plane nearest it (Refer to Figure 1).

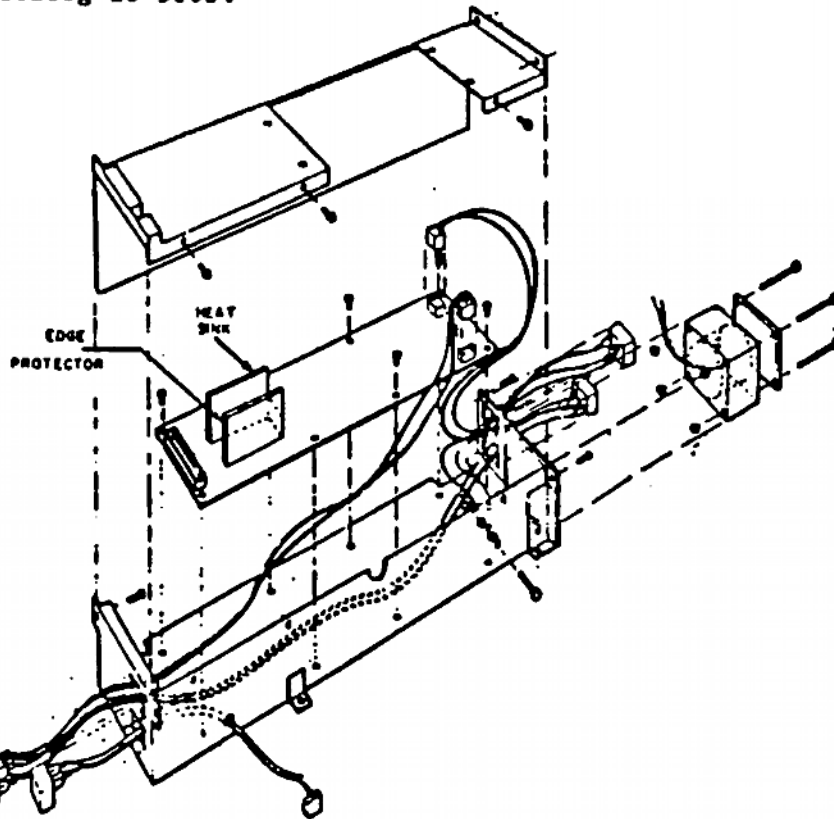
Due to the close fit of the power and reset switch wiring harness to the large heat sink on the power supply, it is possible the heat sink could rub against the wires causing a short. To prevent this, an insulating edge protector should be installed on the right side of the heat sink.

The edge protector is available from National Parts under part number AHC-3100 and catalog 26-5103.

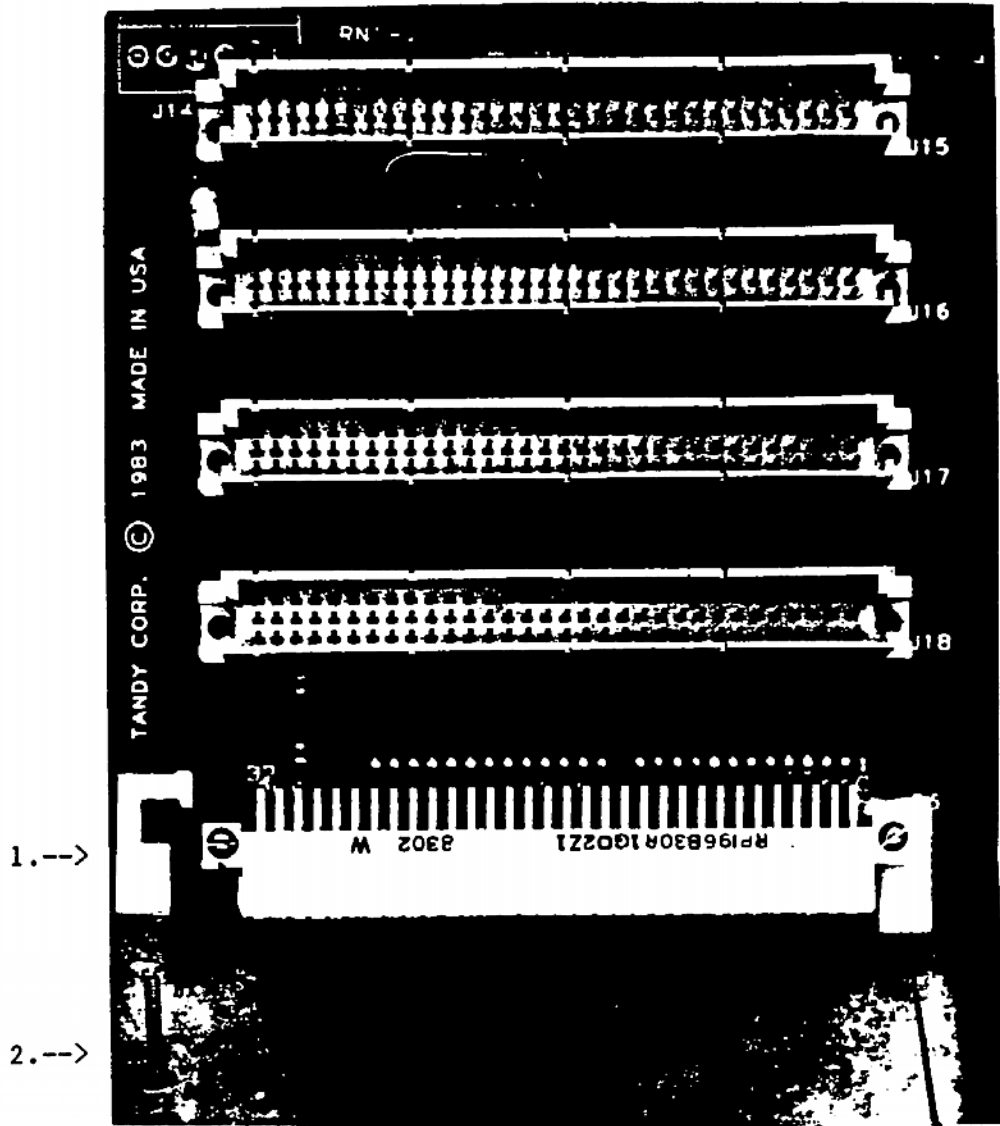
Figure 1.

DISCUSSION: Due to improper seating of the mother board to the main logic board, intermittent bootup, video, or power problems may occur. The four screws which hold the main logic board and pan to the plastic case often times become stripped and creates a bad connection to the motherboard. To insure proper connection is made between the main logic and motherboard, a Retainer Kit is to be installed on the motherboard.

3. (Refer to figure 1.) Remove screws and nuts holding (P6)(96-pin connector) to the motherboard. Replace the original screws with the #4 x 1/4" screws and the #6 lock washers. These are used to hold the retainer clips tightly in place.

4. (Refer to figure 1.) Place the retainer clips over the screw ears of the connector (P6) behind #6 lock washer if used.
5. Reattach the main logic board to the pan. Reinstall the mother board and insert the two screws into standoff's from bottom side. Thread the two screws into the retainer clips, pulling the two boards together for a tight fit. WARNING: Do not over tighten the screws or you will strip out the retainers.
6. Reassemble unit and test for proper operation.

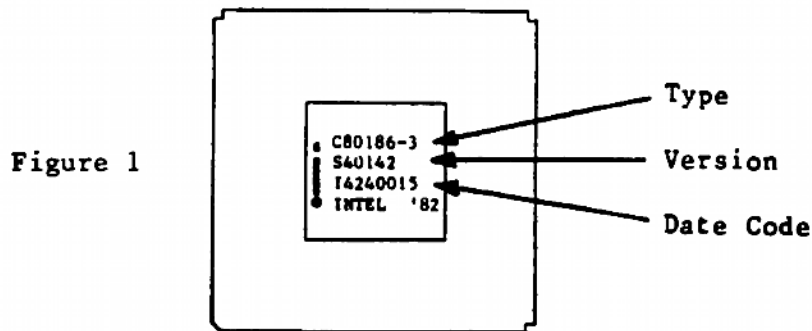
Several versions of the 80186 CPU have been used in the Tandy 2000. Some of these may have missing command functions. Some are 6 MHz speed chips instead of the required 8 MHz. These CPU chips may not exhibit any problems, or only have problems with certain application programs such as a CAD package. Proper identification, and replacement if necessary, is required to insure proper operation.

There are two items to check, clock speed and version number. If either one, or both of these numbers are incorrect the chip must be replaced. Figure 1 shows a typical 80186 CPU chip.
