## The Basic DISK II Pages

### Common Mistakes and Damages to Disk II Controller or DISK II Drives

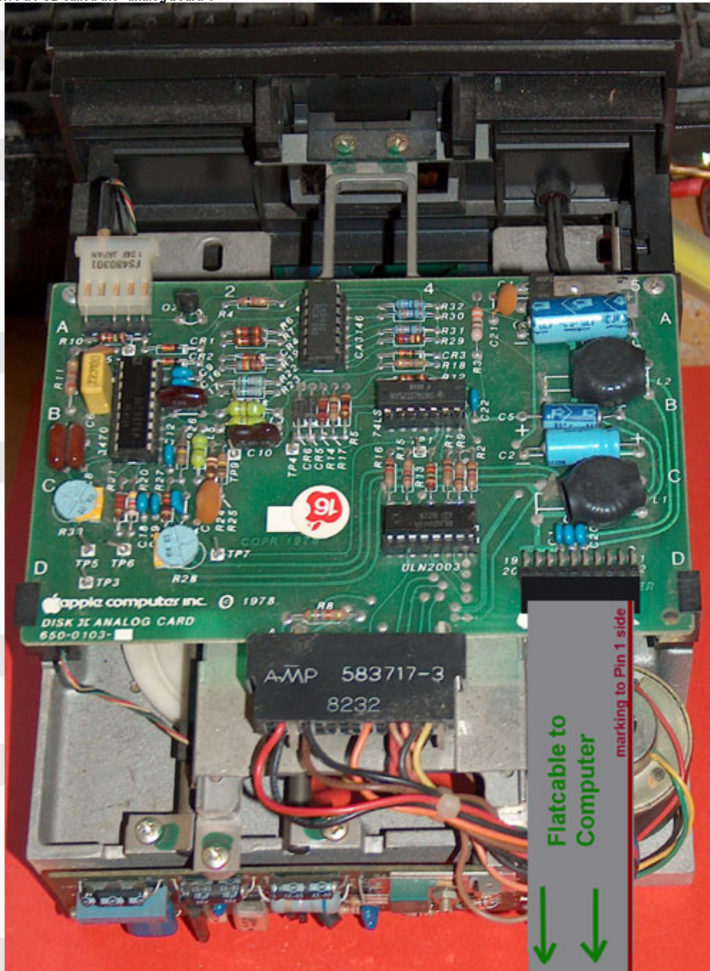
Pay careful attention to the flatribbon cable at the right bottom corner of the picture marked as "Flatcable to Computer" ! recognize at the PCB-Connector where the cable is connected to at the left side of the plug the marking "19" and "20" while at the right side of the plug there is the marking of "1" and below "2" ! Along with the different series of drives the Flatribbon cables have been in the early days so called "rainbow color cables" ( having all the colors also used for indicating numerical values at resistors ) and later being replaced and distributed with grey colored flatribbon cables ( sometimes with attached mounting flaps ). Regardless which cable has been used : You shall mark the side at which the wires of pin "1" and pin "2" run along - and you must mark the cable at BOTH ends ( also that end where you want to plug the cable to the interface ) !!!

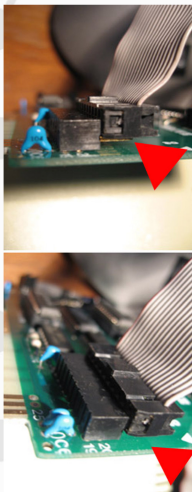
In case the plug has an arrow symbol pressed in the plastic ( like indicated in the right picture with red marking arrow ) make sure - that this really indicates at both sides of the flatribbon cable the side of the cable containing pin "1" and "2" ! If the marking is wrong - then at least mark up the plug correct with permanent marker writing or with "heavy duty label" ( not so easy to remove )

At the left side I display also a very common mistake:  
 Misaligning the plug of the cable at the analog board by leaving the bottom row of pins unused and plugging the lower holes of the plug to the top row of the pins. This is same harming as the mistake by twisting the sides of the cable and plugging pins "1" and "2" of the analog board to pins "19" and "20" at controller side or vice versa!

Both mistakes will cause same result: Because the "analog Board" gets wrong voltages of the supply to the board you will "fry" the circuits on that analog board by making shortcuts or by connecting voltages with wrong polarity!  
 In both cases you must afterwards test and change the IC's at the board - if you are lucky... if not - you might have "fried" parts of the interface or the Apple itself! ( In case you did not immediately shut off Apple again after malfunction.)

Be sure also when connecting cable to the interface to recognize the markings indicating the side related to pin "1" and pin "2"!

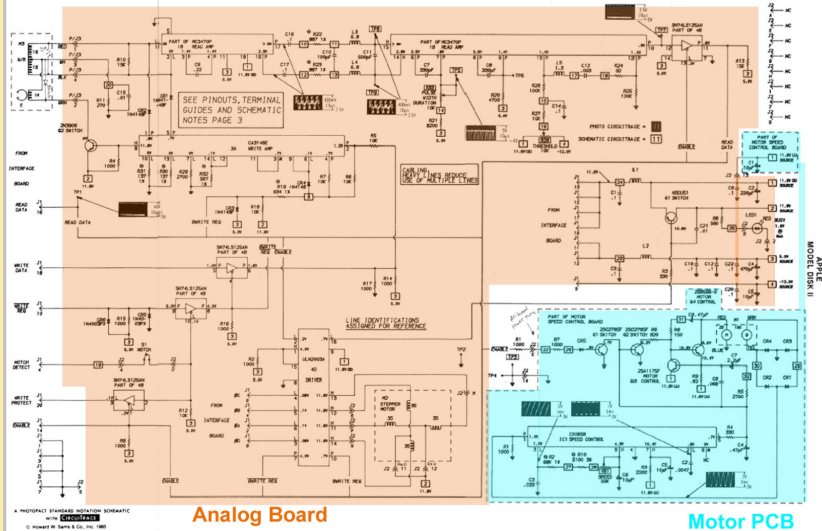
If the plugs have been misaligned for any kind of reason - we will now take a closer view to the circuitplan of the Analog board - and the Motor PCB - the parts related to the PCB are marked in the Circuitplan in same color as the PCB Name:

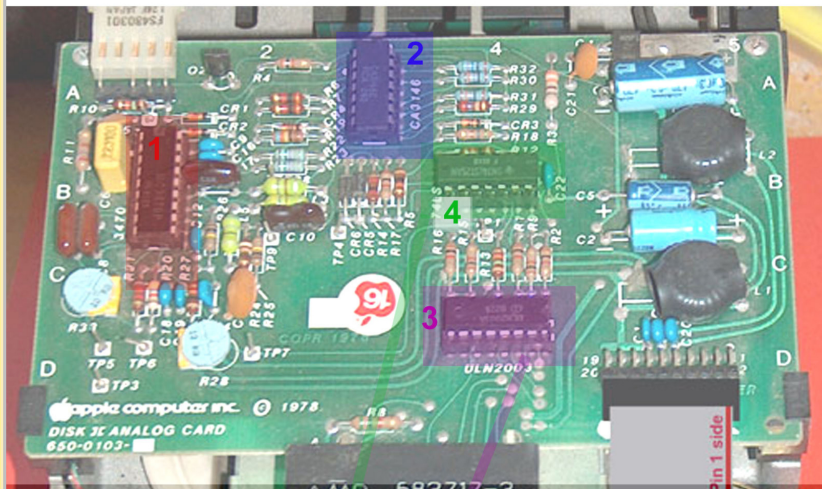
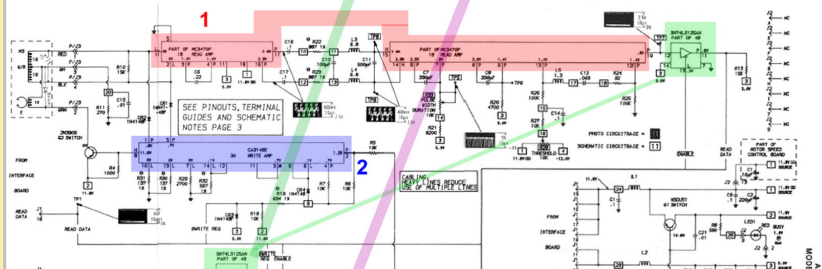
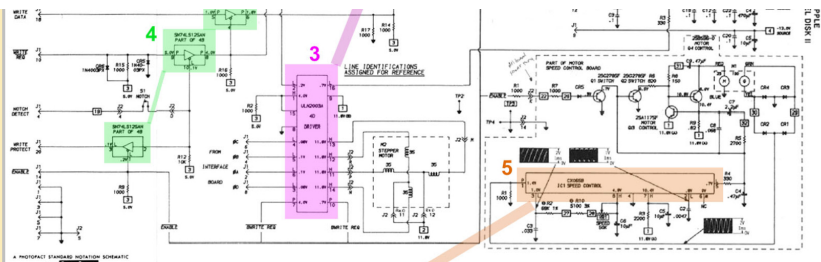
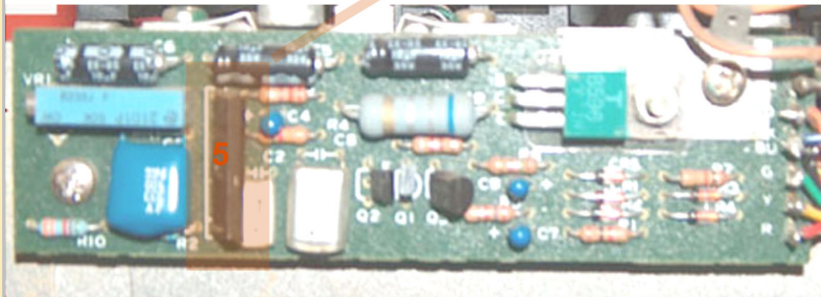
## Allocation of ICs at PCB and at circuitplan

The Hitlist of damaged Circuits is in the order how fast this circuits will be killed at missalignment of the cables and a link to replacement part: 74LS125

<http://www.jameco.com/1/1/25351-74ls125-is-quad-bus-buffer-negative-enable-3-state-dip-14-74ls-series.html>  
the chance that this chip has been killed is about 100% ..... It's the first one that will be killed after about 5 to 10 seconds of power up

Apple II with misaligned plugs  
If this chip is damaged several logic states will be affected - for example also the write protection detection is out of order - instead of reading a disk it might happen that an empty buffer is written to a disk containing information and by that erasing the previous contents - the disk activity LED might probably not work and show that disk in active status. some people at the applefritter forum mentioned that the 74 ACT 125 would not even replace the 74LS125 - but even would be better choice for replacement.....

MC3470P  
<http://www.ebay.com/itm/MC3470P-Original-New-Motorola-Integrated-Circuit-Replaces-NTE3470-400380197238> pt=LH\_DefaultDomain\_0&hash=item5d3884f976  
the chance that this chip has been killed is about 70% ..... It will be killed after about 10 to 20 seconds of power up

Apple II with misaligned plugs  
If this chip is damaged there will not be any read operations possible at the drive !  
If this chip must be replaced the read/write part of the PCB must be readjusted  
- because there is a possible drift at the offset-voltages !

CA3146  
<http://www.ebay.com/itm/RCA-CA3146E-High-Voltage-Transistor-Array-IC-Hard-to-Find-Great-Price-Look/2911611957237>  
the chance that this chip has been killed is still about 70% ..... It will be killed after about 10 to 20 seconds of power up

Apple II with misaligned plugs  
If this chip is dead the erasing function of the diskdrive and the writing condition of the read/write head will be affected and there is danger that all disks will get erased without predictable results.

ULN 2003  
[http://www.jameco.com/webapp/wcs/stores/servlet/Product\\_10001\\_10001\\_1147178\\_-1](http://www.jameco.com/webapp/wcs/stores/servlet/Product_10001_10001_1147178_-1)  
the chance that this chip has been killed is about 25% ..... It will be killed after about 1 to 2 minutes of power up

Apple II with misaligned plugs.  
If this chip is dead this will affect the stepping motor and the recalibration during power on and boot up.  
CX065B  
[http://www.ebay.com/itm/CX065B-Original-New-Sony-Integrated-Circuit-CX-065B-8-759-602-65-400680076292?pt=LH\\_DefaultDomain\\_0&hash=item5d4a64c404](http://www.ebay.com/itm/CX065B-Original-New-Sony-Integrated-Circuit-CX-065B-8-759-602-65-400680076292?pt=LH_DefaultDomain_0&hash=item5d4a64c404)

This chip is nearly never killed because  
before this happens you will have seen smoke coming out of the drive  
while the other 4 ICs would have been fried and cooked !  
If this chip is dead then there will be no correct speed control of the disk spinning motor.

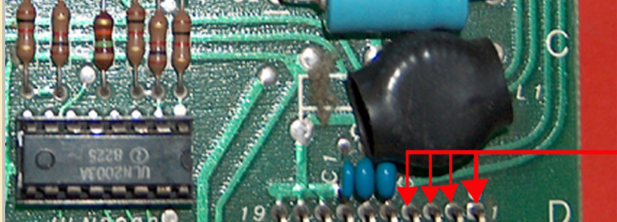
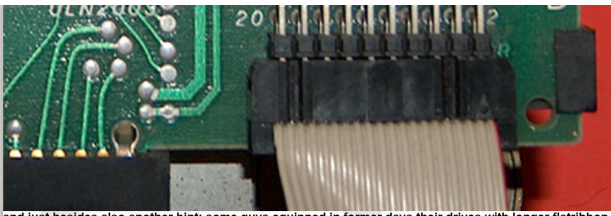
closeup to pins of cablepost connected to Ground

3. often forgotten: if disk drive is dismounted often the shielding plate is removed to attempt the parts below... and often its not really mounted back properly... it's also good idea to get better electrical connection of the shielding plate to "solid electrical ground" - it's funny that engineers at Apple didn't be aware of the leaking connection between shielding plate and ground... the diskframe is only bad electrical connection:  
solution: solder a flexible wire to the shielding plate and at the other end of the ( rather short ! ) flexible wire mount a pin- connector and add ( +close to the large filtering capacitors at the analog bord at their minus pol ( which is the general ground of the drive ) a pin where that wire connector may be attached to.... this ensures much better operation of the shielding function of the shielding plate....  
Hint to find Ground at the analog board: Pin 1,3,5 and 7 at the connector of the analog board to the plug of the cable to the interface are connected to Ground
