The Basic DISK II Pages

Speedadjustment **project**

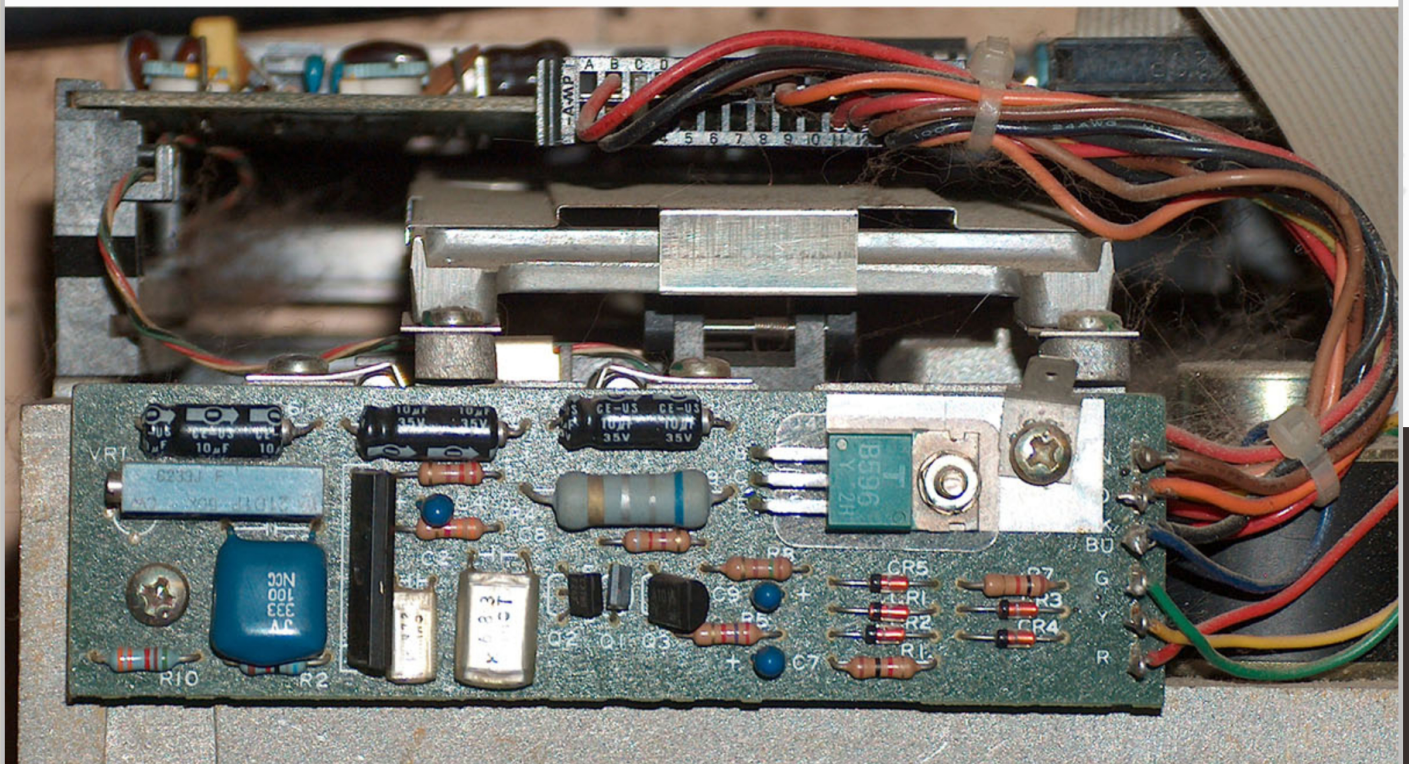
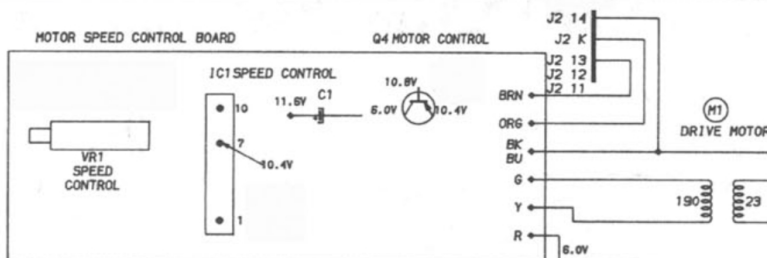
external wiring

The drawings below also indicate some values of voltages and the points where they should be measured.

10.4V
PIN 7

Q1
SWITCH

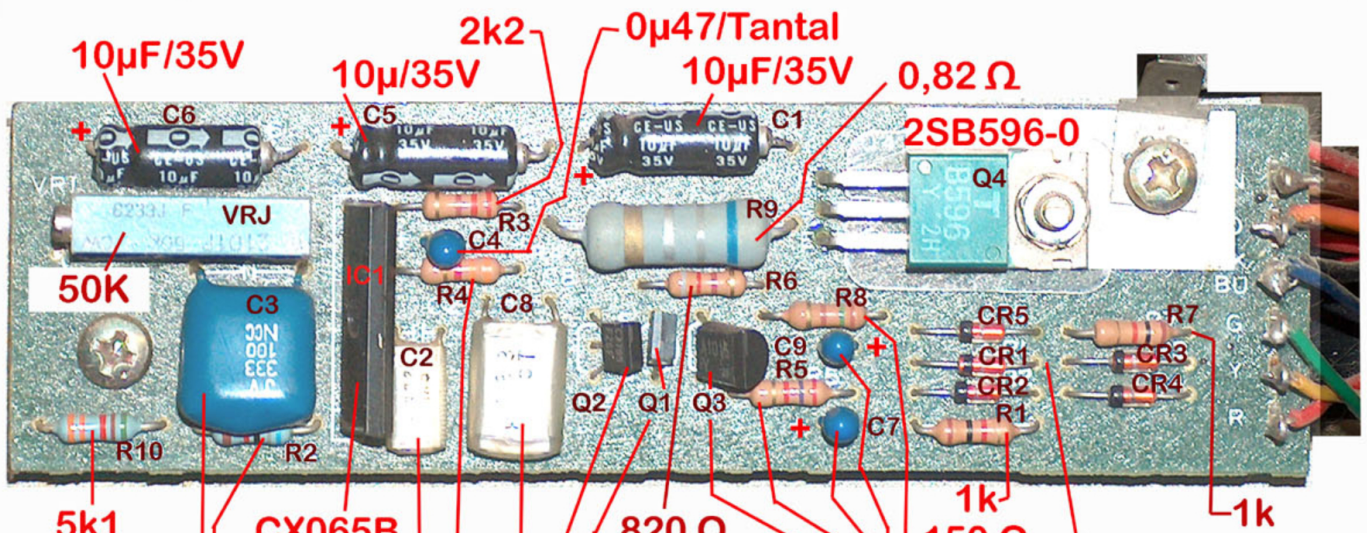
Component Values

This can be verified by the following evidence: the problem remains to adjust the drivespeed to accurate speed and the speed remains within a wider variety than normal usual. normally speed can be adjusted to remain within a limitation of variety about 0,5 %. If it exceeds more than 0,5 % there is a chance that the electrolytic capacitors are getting dry by age and need replacement. In such case the ESR-measurement-values of the capacitors drop dramatically. There are also Tantalum capacitors at that speed-control board. They are normally not affected by this phenomenon. The affected capacitors are: C1, C5 and C6. In the picture at the bottom of the page the values of that capacitors are displayed.

Due to age in very rare cases it might turn out to become required to "recap" the electrolytic capacitors of the speed-control board.
