## The Basic DISK II Pages

### Common Mistakes and Damages to Disk II Controller or DISK II Drives

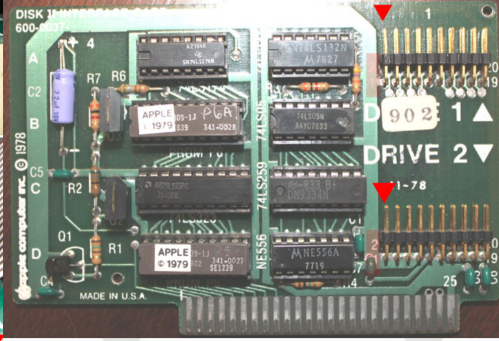
Both mistakes will cause same result: Because the "analog Board" gets wrong voltages of the supply to the board you will "fry" the circuits on that analog board by making shortcuts or by connecting voltages with wrong polarity!  
 In both cases you must afterwards test and change the IC's at the board - if you are lucky... if not - you might have "fried" parts of the interface or the Apple itself! ( In case you did not immediately shut off Apple again after malfunction.)

Be sure also when connecting cable to the interface to recognize the markings indicating the side related to pin "1" and pin "2"!

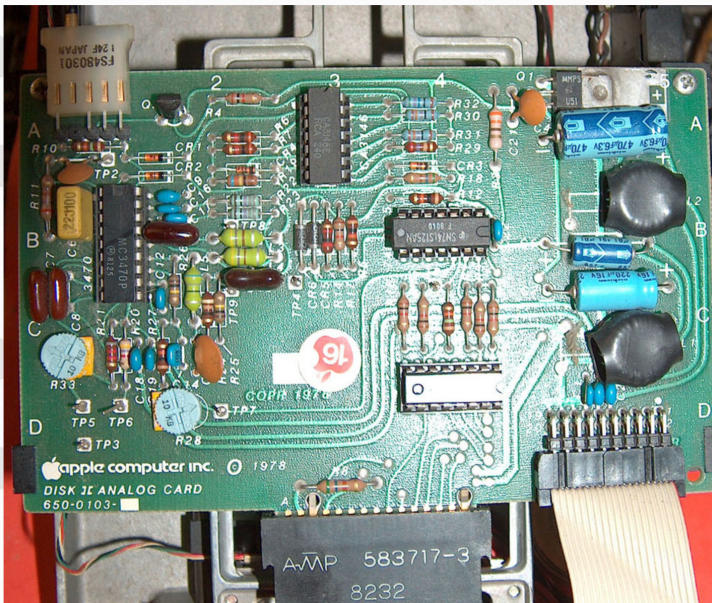
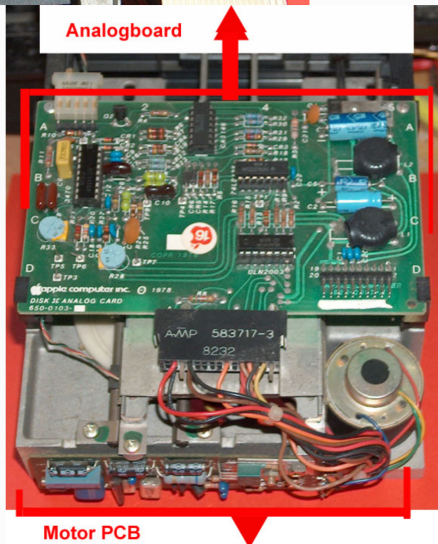
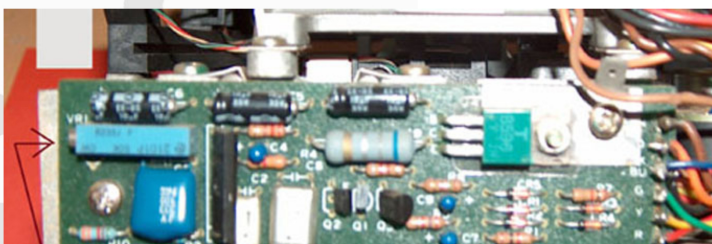
**screwtop of adjustmenttrimming resistor responsible for speed**

At this place a short intermezzo back to the PCBs of the Disk II:  
 The Analog Board has simple Voltage filtering, the entire Read/Write Logic and  
 - the preamplifier and Amplifier for the Read/Write head and  
 - some simple logic for switches acting as detectors ( like the write protection switch) and  
 - buffering of the track signals that afterwards are sent to the Motor PCB.

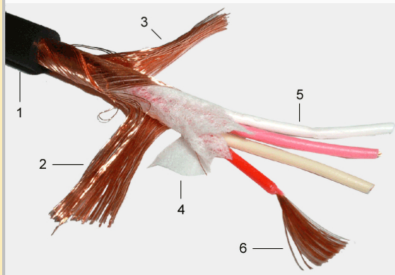
1. the cable from "Analog board" to read/write head is not shielded and it transmits delicate signal... possible solution: changing that very thin cable to a very thin shielded special microphon-cable (with isolated 4 "core" wires !)  
the problem: this special shielded very thin cables are very rare (!) and very extreme expensive (!) hard to get (!) and you have to find one, that is exactly same flexible like the unshielded one formerly used and to be replaced and you have to be very careful while soldering ( the read/write head is very sensible ! )  
short research:  
<http://ex-en.alliedelec.com/search/productdetail.aspx?SKU=70004649#tab=specs>  
or  
[http://www.gotham.ch/en/index.php?section=docsys&cmd=23\\_details&id=15](http://www.gotham.ch/en/index.php?section=docsys&cmd=23_details&id=15)

-It is even not sure that this cables will fit the needs....  
- first cable seems not to be flexible enough and second seems to fit ... if it is thin enough

- it must be previously issued some questions to the seller:  
is the "total"-cable ( referring to the outer diameter of the cable ) really very thin ( less 3mm ) and very extreme flexible ?
