TECHNICAL BULLETIN INDEX
Sorted by Bulletin Number
04/03/86

TANDY COMPUTER PRODUCTS

DATE: December 8, 1983
REVISION DATE: April 18, 1988
BULLETIN NO: 2000:1
PRODUCT: 26-5140 High Resolution Graphics PCB
SUBASSEMBLY: AX-9450 Graphics PCB
SUBASSEMBLY REVISION: Rev. PP2

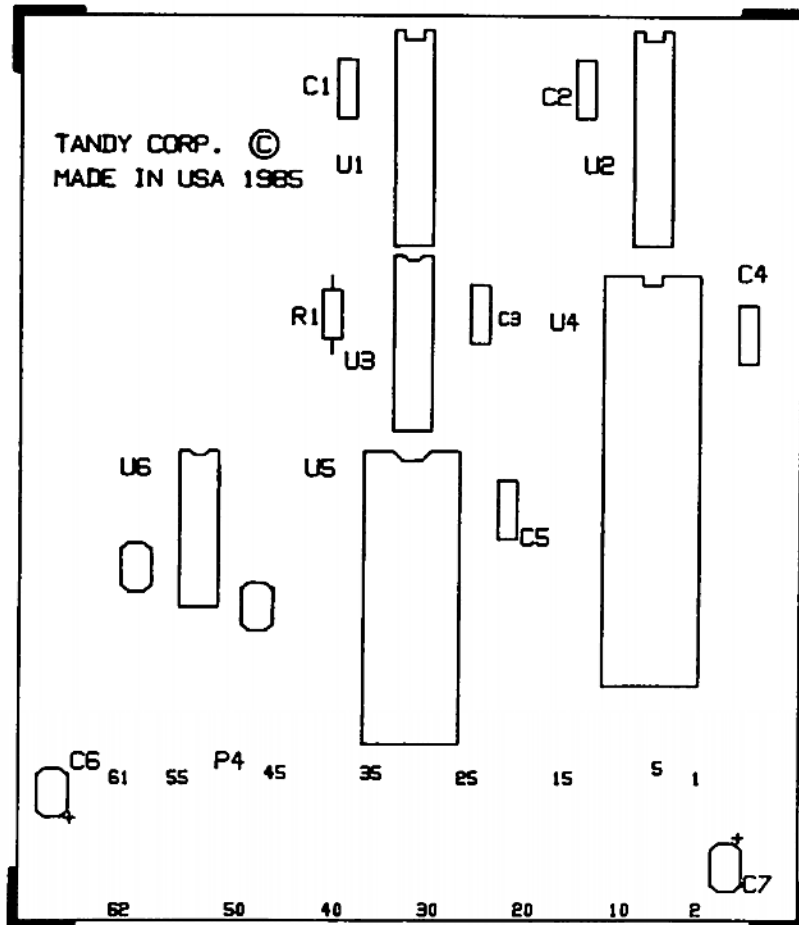
Tandy 2000 8087 Numeric Coprocessor Component Layout

The iAPX 8087 identifies numeric instructions by monitoring the bus activity of the 80186 CPU. Two sets of status lines (S0* - S2* identify the type of bus cycle, and QS0 - QS1 identify queue operations) inform the 8087 of the bus cycle being run as well as the status of the CPU's internal queue (the 80186 maintains a queue up to six bytes long from which opcodes are fetched). A certain class of instruction codes (ESCAPE opcodes) have been reserved for the numeric coprocessor extension. In response to an ESC opcode, the 80186 computes the EA (Effective Address) identified by the opcode, and does a single memory read from that address. The 8087 decodes the ESC instruction tandem with the 80186 and (if necessary) grabs both the data and the address generated by the CPU. If further bytes need to be fetched to complete the instruction, the 8087 informs the 80186 of its status by outputting BUSY (active high while doing a numeric operation). The CPU has an instruction (WAIT, no operands) that waits for its TEST* (active low) to go active before it continues. All 86 family assemblers insert a WAIT instruction before floating point instructions unless explicitly directed not to do so. That way, the CPU does not embark on a new numeric instruction before the last one has completed its execution. Interface between the 8087 and the 80186 is performed by the 82188. This device provides system READY synchronization, converts the RQ/GTn* bus master control convention of the 8087 to the HOLD/HDLA convention of the 80186, synchronizes the QSn* lines of the 80186 to the 8087, and provides RD*, WR*, and ALE strobes by decoding the S0* - S2* status lines that are common to both the 80186 and the 8087.

Additional logic on the circuit board regenerates the MCS0* and MCS1* (Memory Chip Select 0 and 1, active low in 00000H - 1FFFFH for MCS0* and in 20000H - 3FFFFH for MCS1*) that is generated by the 80186 so that the 8087 may access these areas also. In order for the 8087 to properly track accesses to the UCS* (Upper Chip Select, active low in F8000H - FFFFFH), SRDY (Synchronous Ready, active high) must be held inactive to maintain the appearance of a three wait state access (the 80186 is programmed by the boot ROM to run a three wait state access to this area).

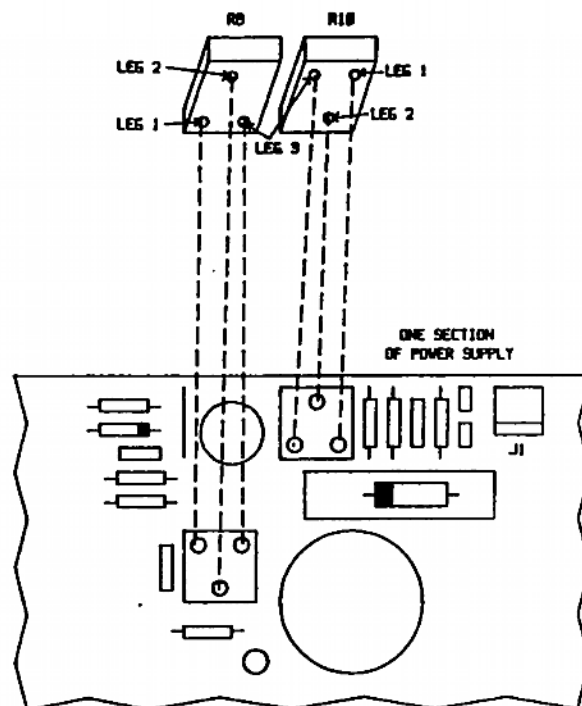
The power supply for the Tandy 2000 has two potentiometers. One to adjust the +5 volts (R10) and another to adjust the +12 volts (R8). During operation it has been found that these potentiometers will change value. This could cause the voltage to increase which in turn causes the power supply to go into current limiting mode; shutting itself down and rebooting the computer.

To eliminate this voltage fluctuation, the potentiometers must be replaced with fixed resistors. Two items must be noted here. First, the required resistance may not be a standard value resistor which will indicate that a series and/or parallel resistor combination must be used. Secondly, the +5 volt potentiometer will require two resistors (or combinations) where as the +12 volt will only require one resistor (or combination). This is because the +12 volt potentiometer's slide arm is connected to one of its fixed legs.

5. Install the first fixed resistor between the holes on the power supply PCB vacated by Leg 1 and Leg 2. Install the second fixed resistor between the holes vacated by Leg 3 and Leg 2. This completes the replacement of the +5 volt potentiometer.

7. Install the fixed resistor between the holes on the power supply PCB vacated by Leg 1 and Leg 2. This completes the replacement of the +12 volt potentiometer.

8. Reinstall the power supply PCB and check for proper voltage levels on the +5 volt and +12 volt sections.
