The Basic DISK II Pages

Speedadjustment, Trackalignment, Cleaning and Service project

page about calibrating the track zero

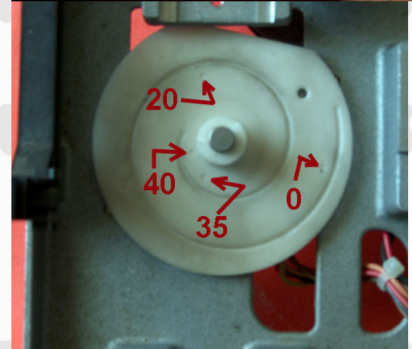
In this stage you will be able to see the entire positioningdisk - this one is still uncleaned and i want to guide your attention to the 4 small spotmarks drilled into the material. They mark 4 important points and are from the factory ..... they indicate the position where the steelball of the steelspringplate should be when the sled is positioned to "fixpoints" at :
track 0
track 20
track 35
track 40.
This indicates that this positioningdisk was manufactured by a company, that also delivered this disk to thirdparty customers that made drives that also could handle 40 tracks (as most of the drives could...), the limitation to 35 tracks was also in those days rather unusual and it was related to the fact that Apple did not use specialized chips for diskhandling on their PCBs. So due to the use of standard chips the use of the "inner 5 tracks" (with more compressed data and higher demands to the electronic read/write compensation were higher and Apple decided to stay away from this inner tracks and believed them to be not safe with the DISKII analogboard.

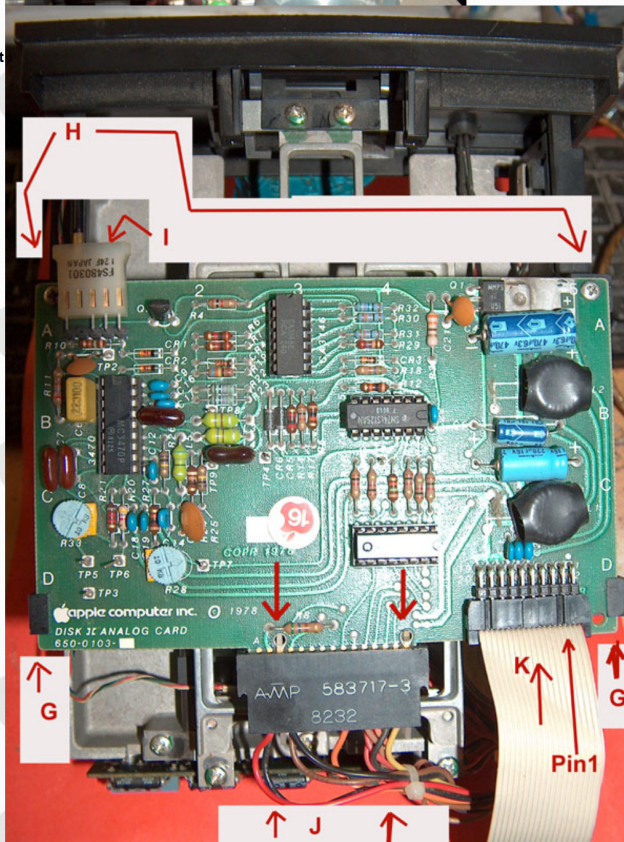
**Remark: Its a common accident that the plug of the flatribboncable is pluged
in the wrong way around at the controller and that kills chips in the electronics !
So it is wise to also mark at this point the cable at the other side by a
penmarker and mark the side where pin1 is at that plug at the controllerside
too to avoid such an accident in the future !**

Take the analogboard and position it in the correct orientation and then
let the board slide into the notches of the plasticframe at the positions
G and then fix the screws at the positions **H**. Thereafter plug the read/write-
head cable to the connector at position **I** and take care of the correct
orientation indicated by the missing pol.

Then plugin the connector with the MotorPCB-cables at position **J**. Take
care of the plastic lockers marked by the arrows ! Then plugin the
flatribboncable at position **K**. Take care that the side of the cable indicated
by a colorside or with the brown or black ribbonside is oriented towards the
side indicated in the picture with pin 1.

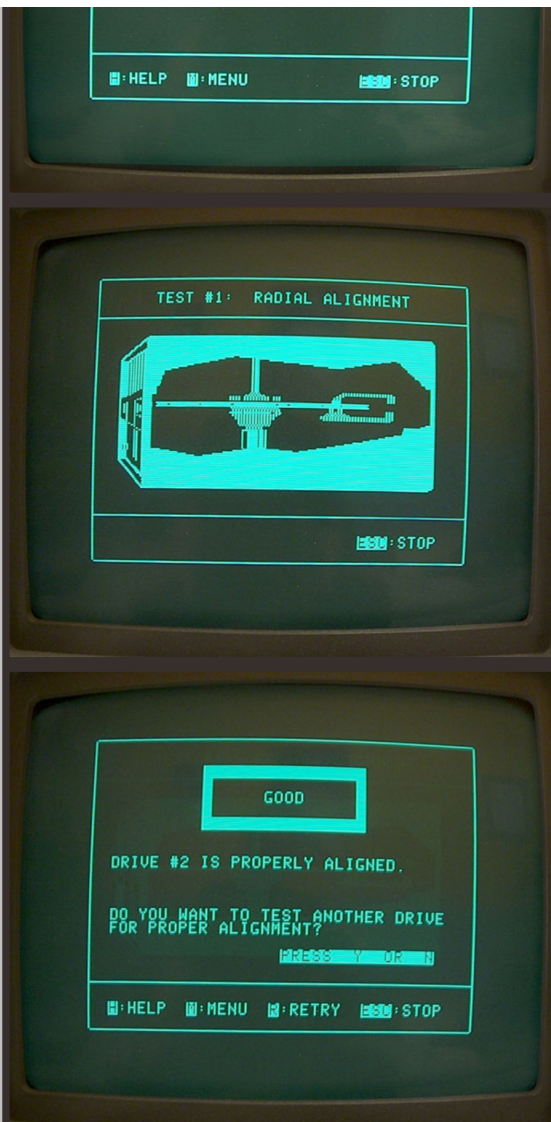
```
            GOOD

DRIVE #2 IS PROPERLY ALIGNED.

If you went along the above displayed menus and options
and recieved this display - congratulations !
You've solved the task successfully !
