Modifikation Maestro 32/96 with booting problems

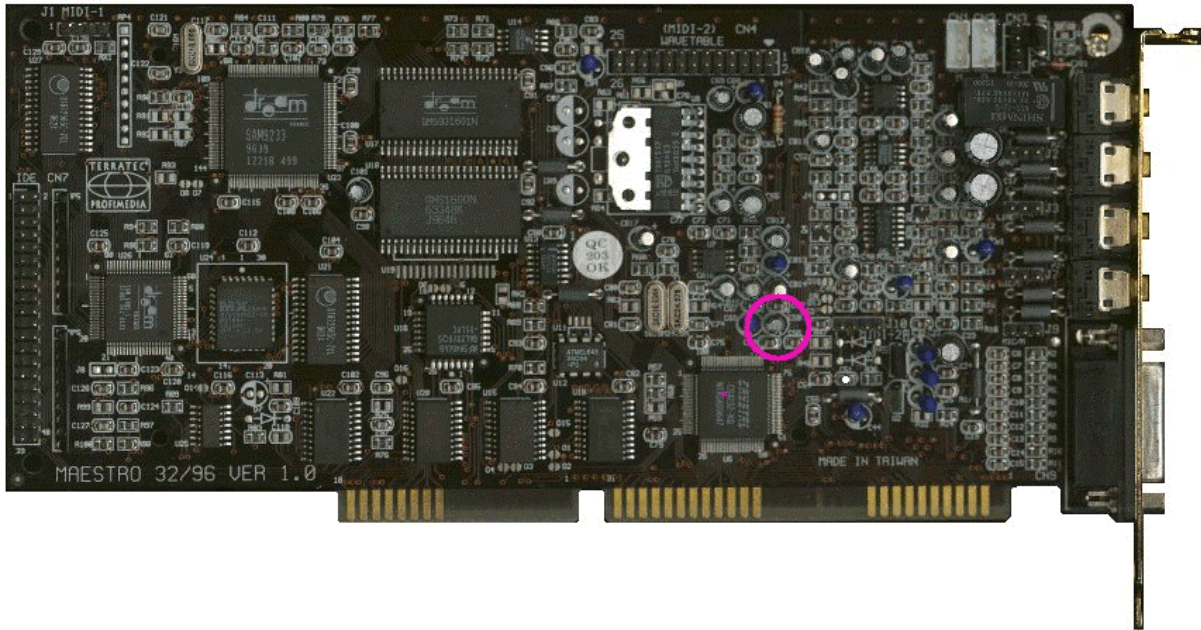
Please note that proper care and attention must be paid when replacing the C58 capacitor, due to the 4-layer architecture of the sound card. Attention MUST also be paid to the polarity of the electrolyte capacitor. As a guide, the area on the top of the board marked in white must match the negative pole of the capacitor. The electrolyte capacitor is a standard component with the following specification: 1 uF, 16 volt and upright design.
